“ River Gravel and Sand Extraction - lessons from Fiji’s experience necessitating development of a management guideline”

Navua -River Nakavu-2018

A River Gravel and Sand Extraction Guideline 2021

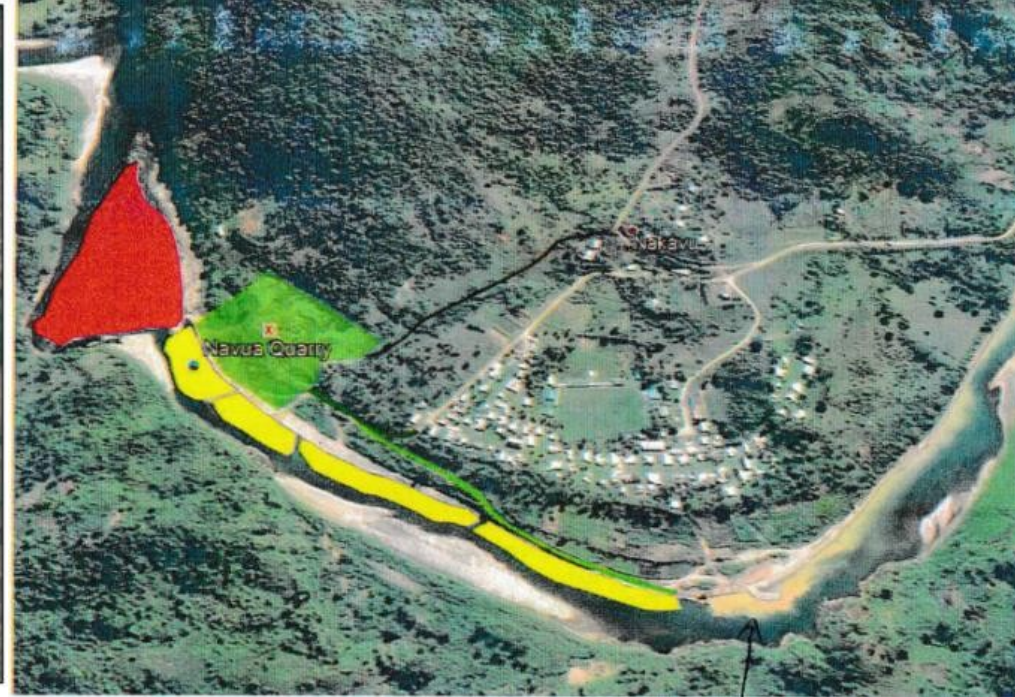
EIA report examples of resource maps for river excavation using mechanical digger

Whats wrong with these resource maps ??

Scale

Shaded area hides non existent resource??

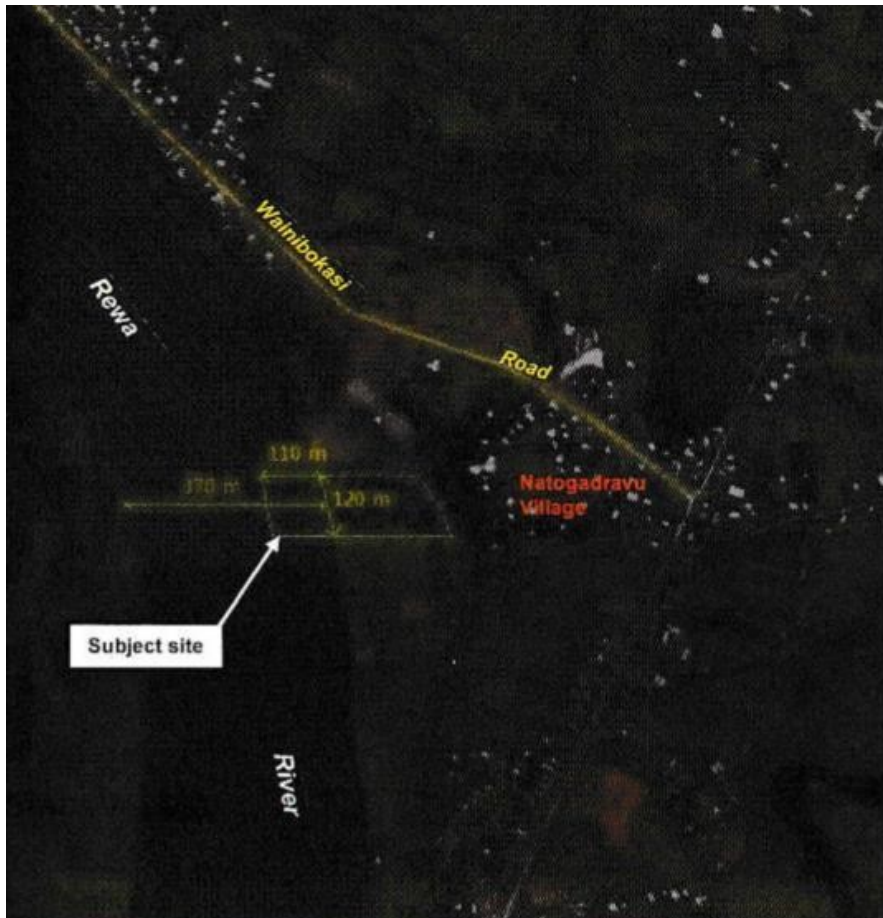
Example resource maps for river dredging from EIA reports

Poorly referenced and technical input into understanding resources and environment are non existent in EIA's which lead to LOU problems through misunderstanding CASE example Waivou River Tailevu

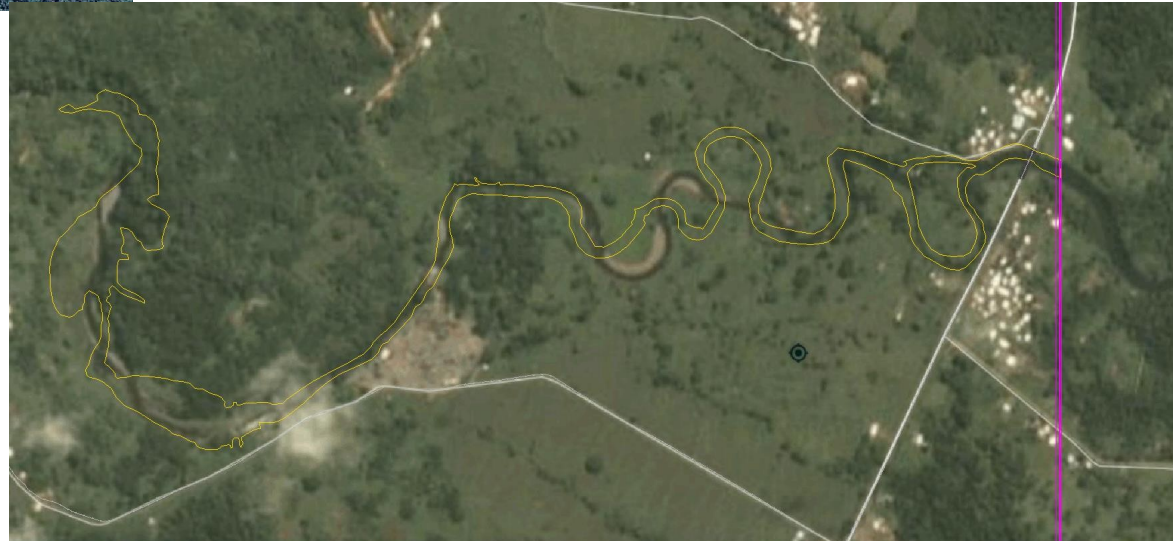
Yellow outline of river
represents river position in
2004

From P-1 to bridge the river
has shorten its course by
600 m since 2004

The closure of a number of meanders potentially
removed a reservoir volume of around 50-100,000 m³
for floods, sediment catchment resulting in increased
estuary sedimentation and village flooding

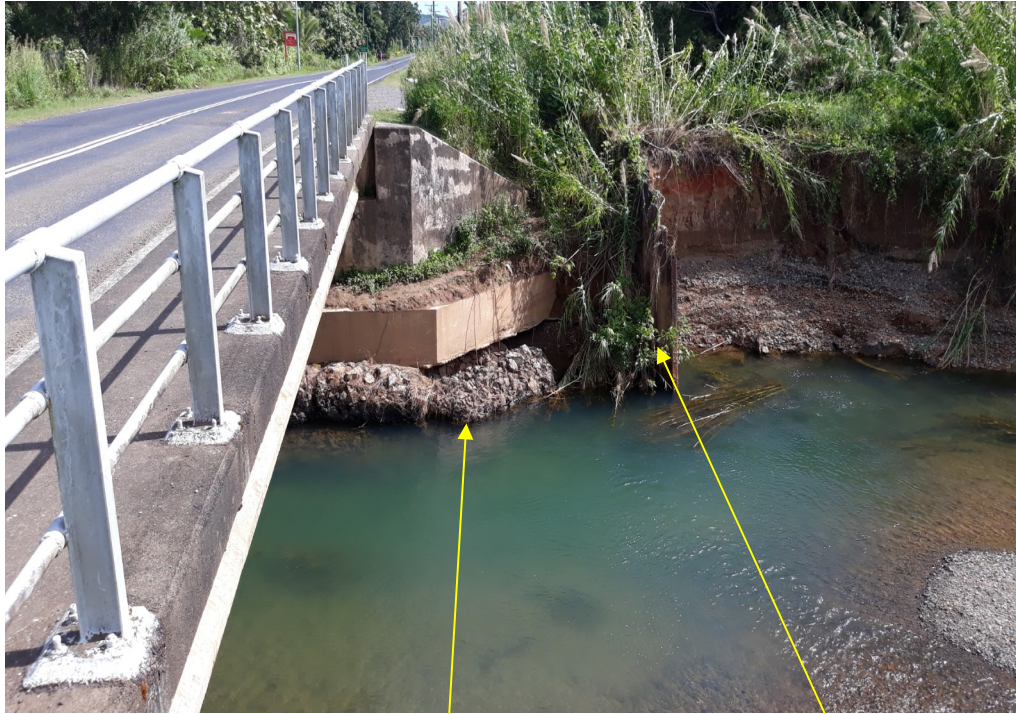
19-05-2019

Gabion basket and protective sheet piling exposed and eroded from behind

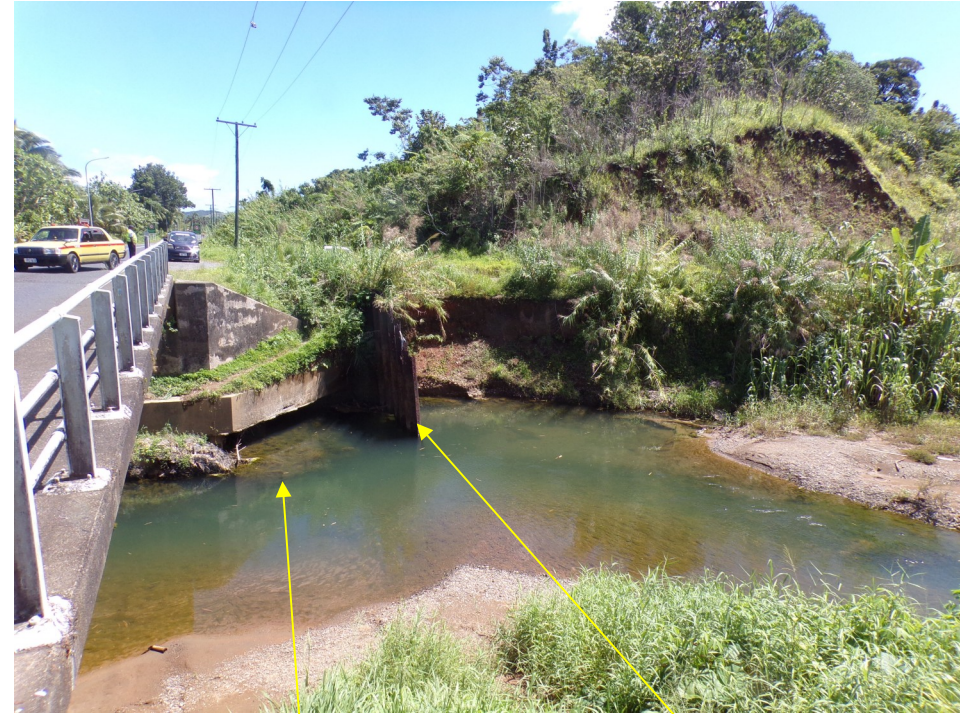
05-04-2021

Gabion basket has subsided presumably undermined and erosion under sheet piling increasing foundation vulnerability of the bridge

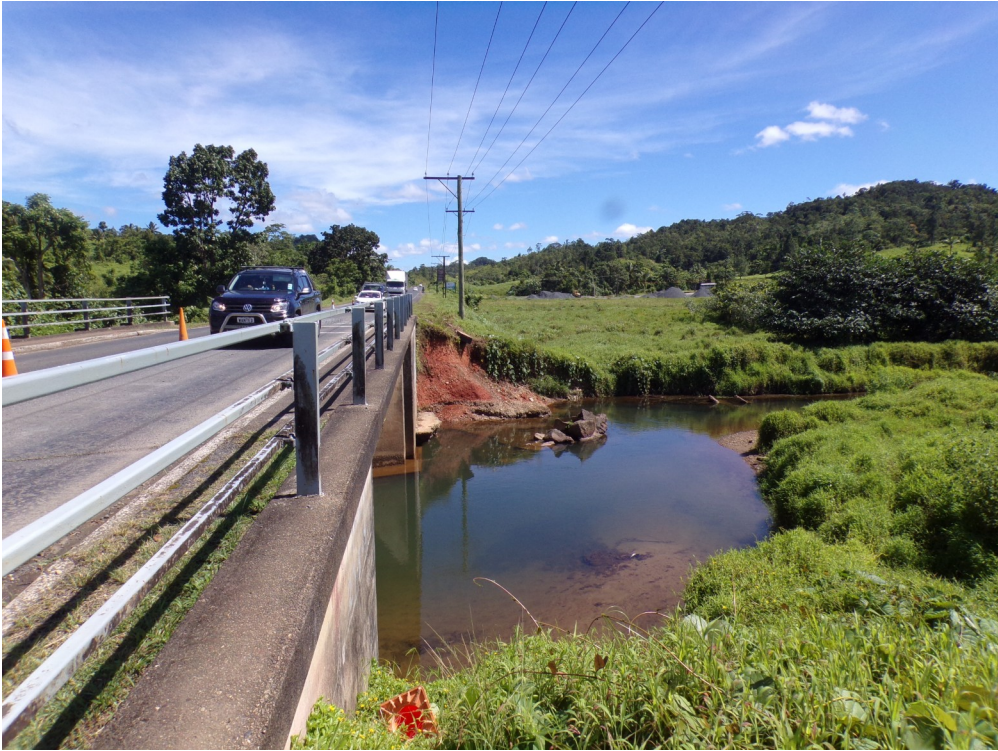
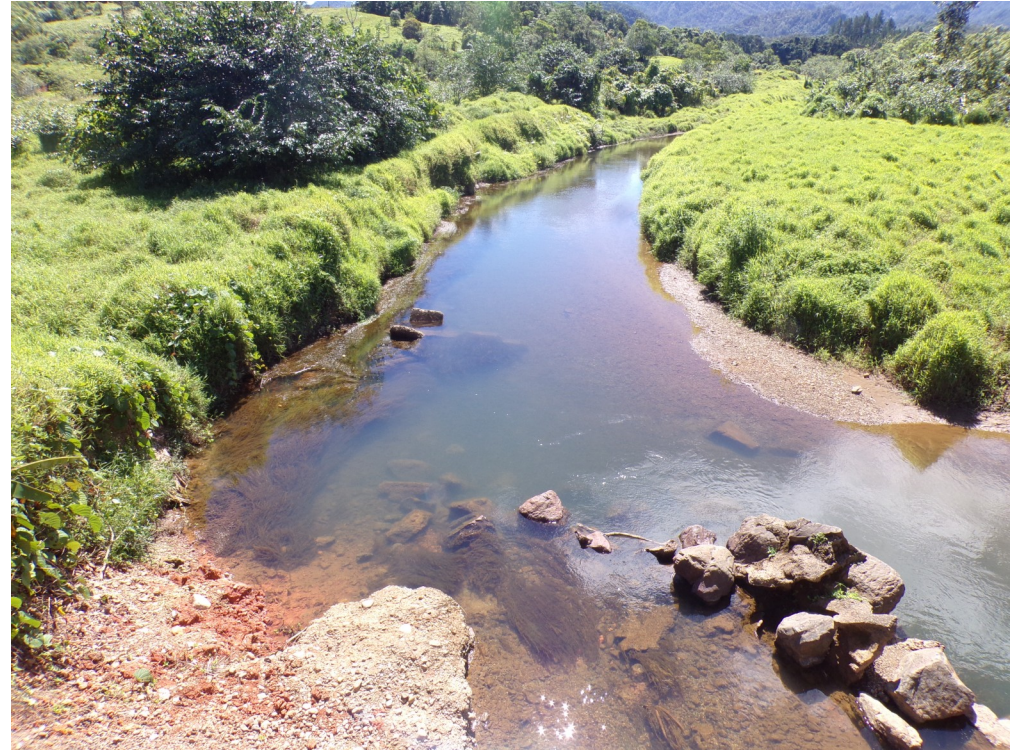
Nubukavesi Bridge 21-04-2021

Leading to expensive remedial works

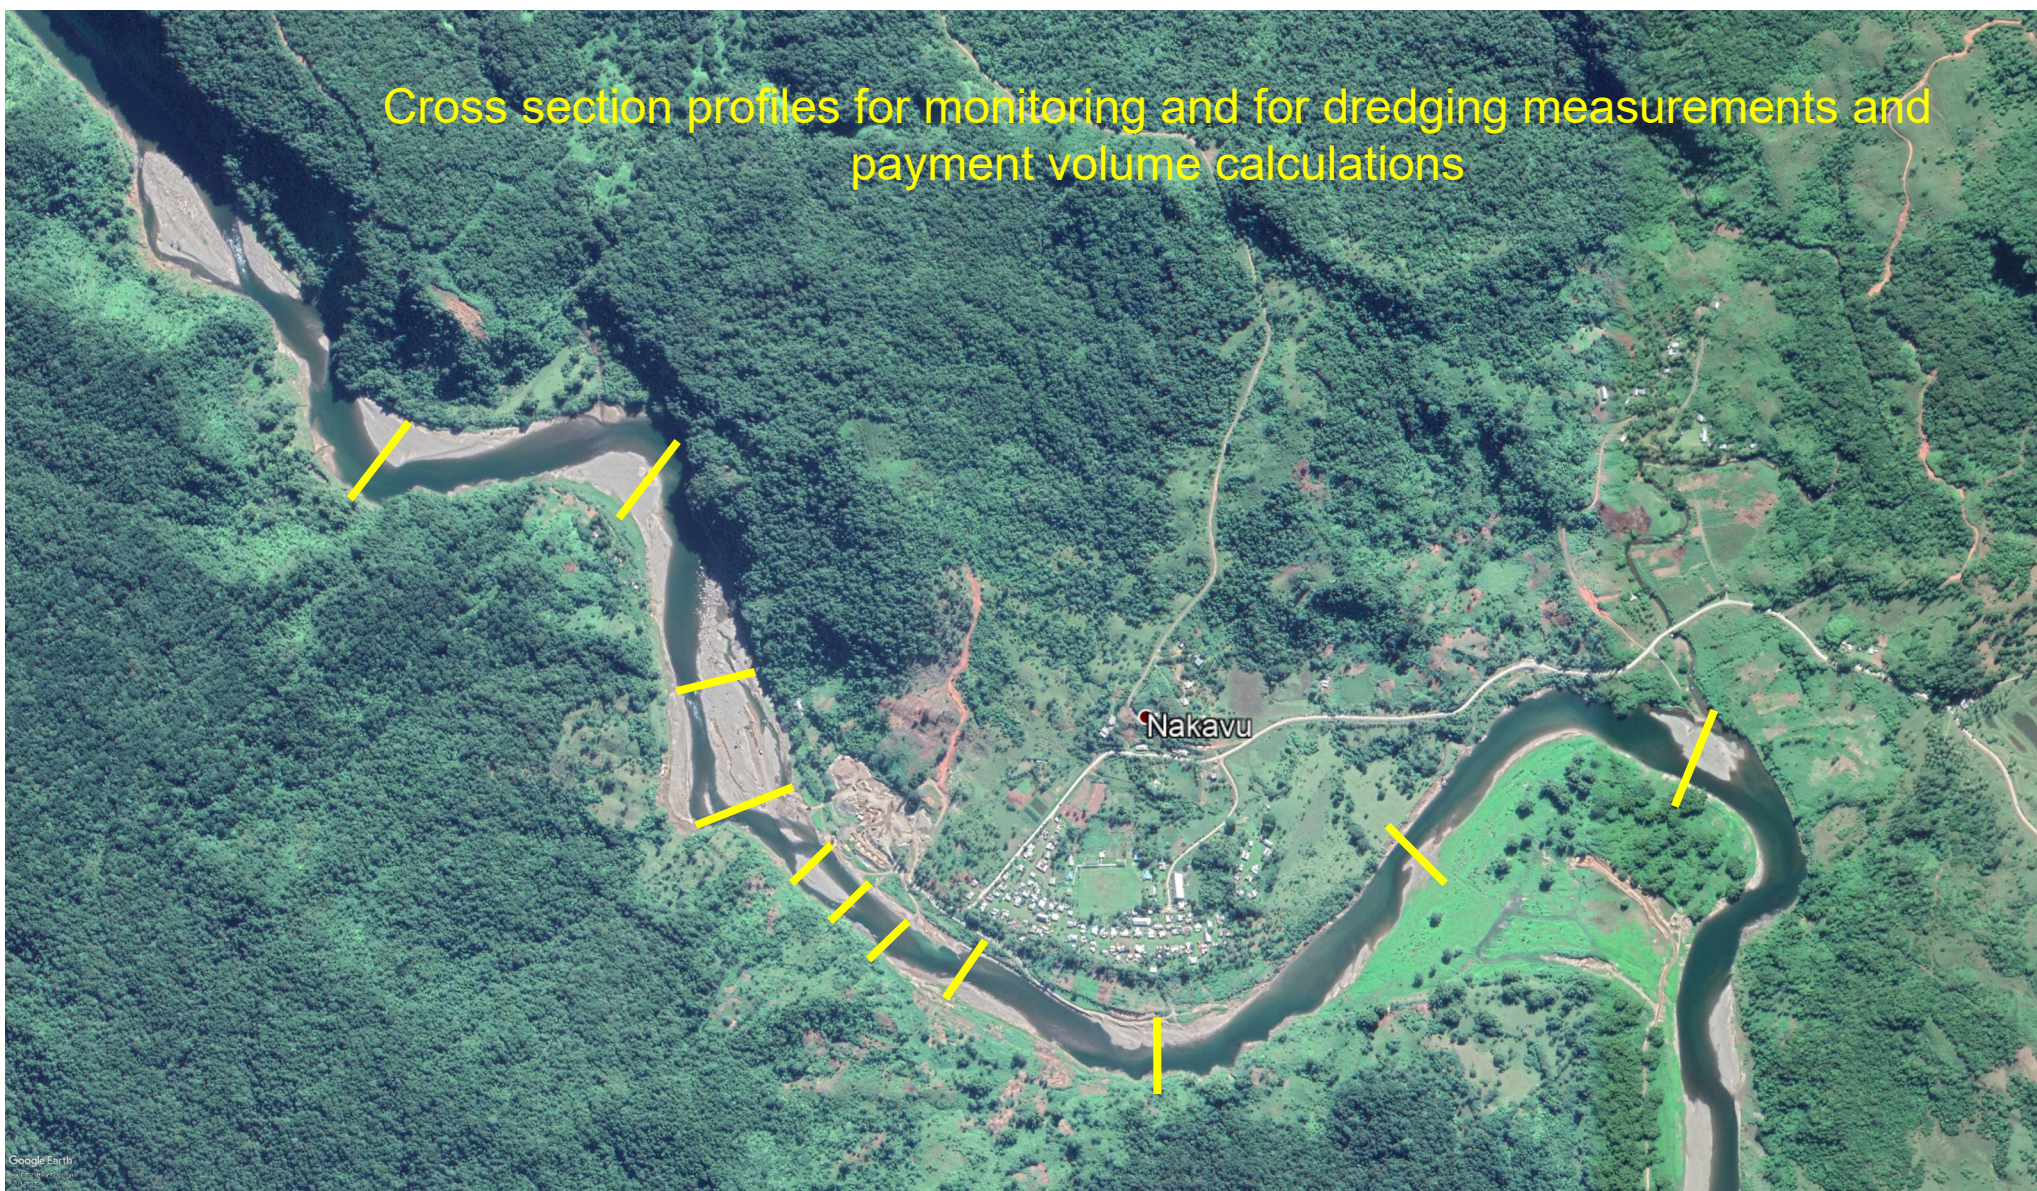
Cross section profiles for monitoring and for dredging measurements and payment volume calculations
